Failure of a Natural Gas Transmission Pipeline—Material or Sabotage

Muhammad Mansoor^{1,*}, Noveed Ejaz¹, Amjad Ali¹, Khalid Mehmood Ghauri², Gul Hameed Awan³

Abstract

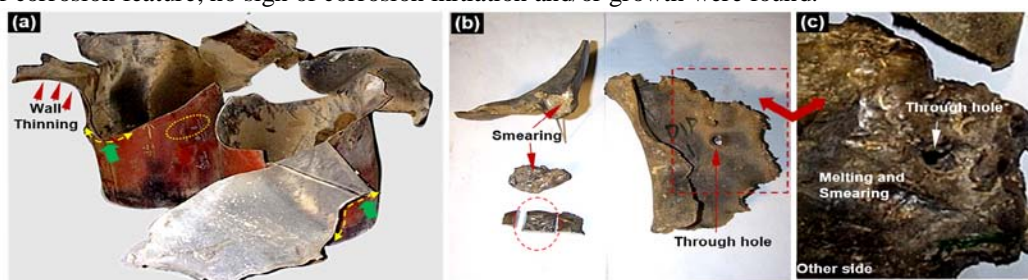
The fractured region was encompassed by 3 to 4 feet length of the pipeline. The general features of failure indicate that the rupture comprised of randomly directed multiple fracture lines, which indicated a characteristic catastrophic failure that gave away some disintegrated fragments of the pipe. These disintegrated fragments were featured with localized melting, pierced-through holes with smeared metal at the edges, severe bending/folding and wall thinning. The fracture path did not follow the weld seam; instead, it was passing across the weld seam. The wall thickness was found reduced to ca. 8 mm in majority of the fracture surfaces (Figure 1a-1c).

Figure 1. a) Fracture regions of the pipeline—fracture path crossed the weld seam (green arrows). A 20x15 in² piece from circled region was cut to prepare samples for mechanical testing, b) disintegrated fragments of the damaged pipe, c) magnified image of the boxed region in (b) showing melting and smearing features.

as, pitting, hydrogen blistering and sulfide stress cracking, etc. Moreover, the fracture path was passing across weld seam instead of moving along it. All these evaluations validate the soundness of the material i.e., material, welding or processing were not accountable for the failure.

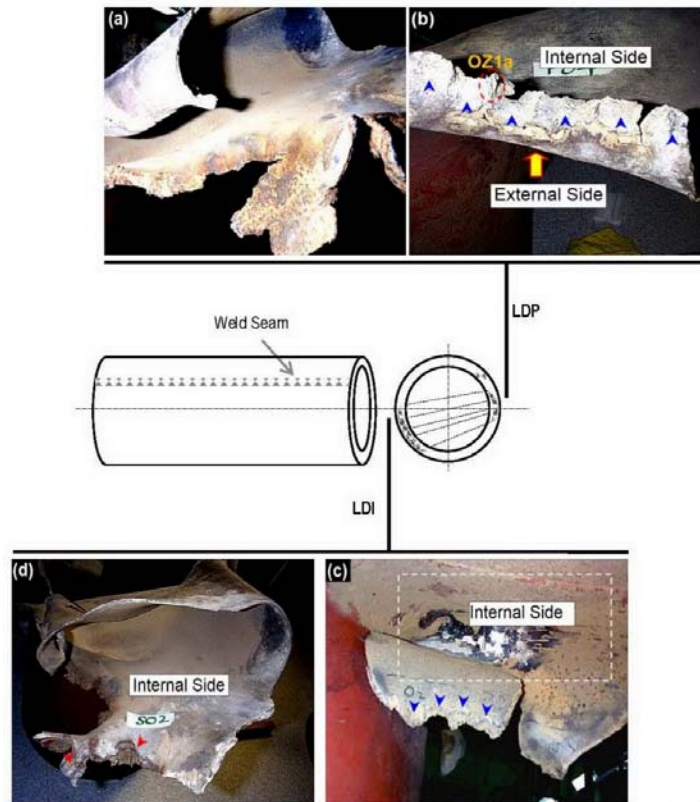
The general appearance of the fracture region was identical except for two locations. These locations are shown schematically in Figure 2 and named as “LDP” and “LDI”. At the location “LDP”, features of external impact were seen (Figure 2a & 2b). These impact features were incorporated with fusion, smearing, and severe penetration from external side. The region of damage was around 180 mm wide along the periphery of the pipe. An ingress pattern of fracture surface along with secondary cracks was seen at this location.

At the location “LDI”, deep indents were observed. These indents were round or oval in shape and accompanied reduction in the wall thickness (Figure 2c & 2b). The damaged region was ~535 mm wide along the periphery of the pipe.

Figure 2. The schematic is showing the orientation of the two discernable fracture surfaces i.e., LDP (a and b) and LDI (c and d): a) Tearing of the pipe wall, b) features of external impact, smearing, and fusion (arrows); sample ‘OZ1a’ was collected from the encircled region, c) wall of the pipe is pressed outward due to severe impact (boxed region) and d) thinning of wall thickness at inner side (arrows).

During macroscopic examination, it was observed that some sort of penetration from external side of the pipe occurred. The penetration caused smearing and severe deformation at the outer surface of the pipe (Figure 1). At LDP location (as marked in Figure 2a & 2b), features of external impact, smearing, and fused metal along with tearing of the pipe wall were present. At the fracture surface of DP-2 (Figure-2b), presence of molten aluminum was confirmed by EDS. Contrary to LDP location, internal impact features were seen at LDI position (Figure 2c & 2d). At this location, thinning along with severe plastic deformation of the pipe wall was observed.

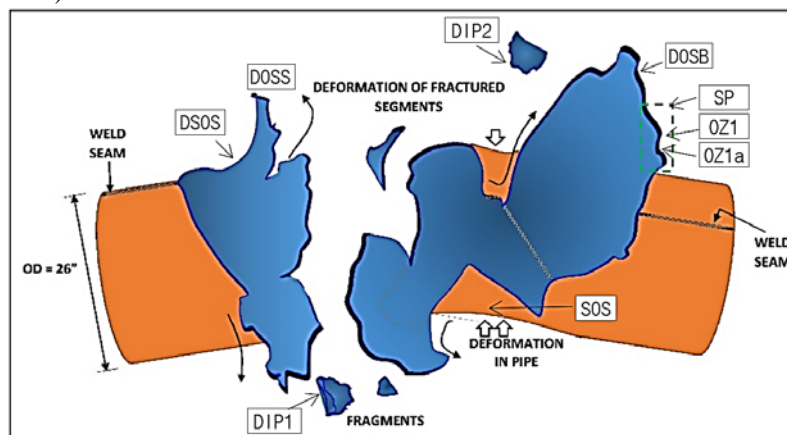
Figure 3. Schematic representation of the observed features of the failure along with the marking of the test specimens.

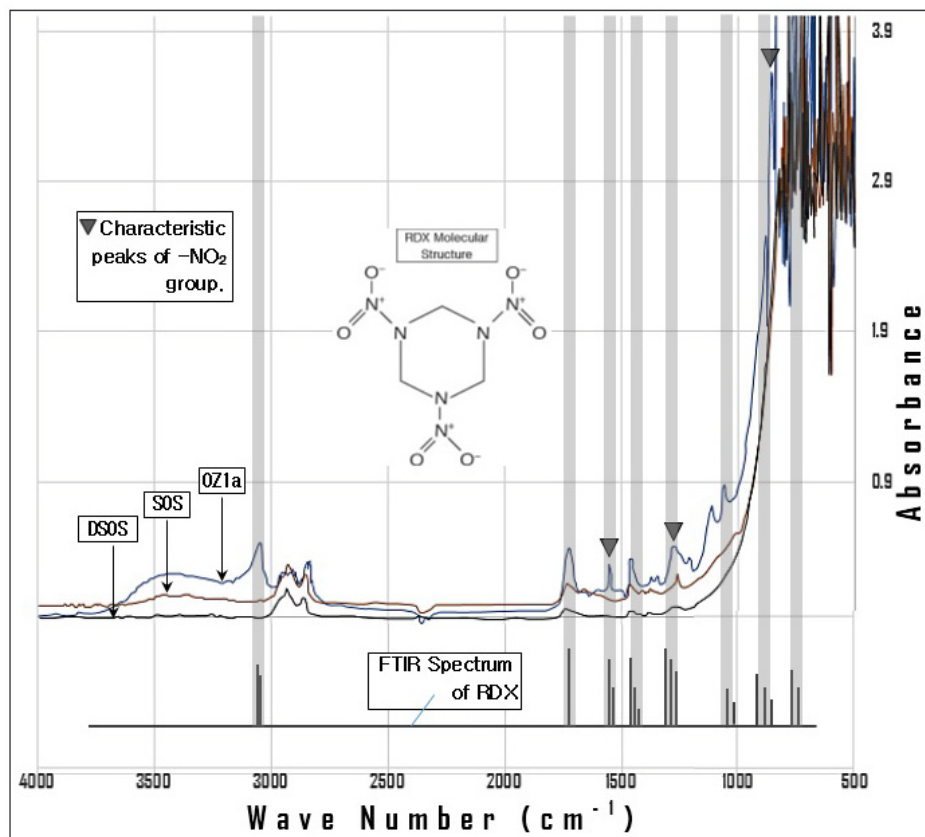
All the specimens mentioned in Table 2 were subjected to the FTIR spectroscopy in the range from 500 to 4,000 cm^{-1} and compared with various types of commonly used explosives i.e., C-4, ETN, HMX, PETN, TATP and RDX. While comparison, only three specimens were indicative of the presence of some explosive residuals. These specimens were SOS (from LPI region), DSOS (from LPD region) and OZ1a (segments of LPD region). The superimposed FTIR scans are shown in Figure 4 along with a peak identifier spectrum of cyclo-trimethylene-trinitramine (an explosive material), which was quoted by some other researchers independently [8].

The FTIR spectra of unexploded and exploded cyclo-trimethylene-trinitramine also known as “Royal Demolition Explosive” (RDX) are comparable. Therefore, the spectrum of OZ1a specimen was substantially analogous with the peaks suggested for RDX exploded spectrum by Yang *et al.* [8]. However, some peaks intensities were found different from the cited reference, which could be due to the limited amount of available traces of the explosive on and around the fracture region. Rest of the two specimens i.e., SOS and DSOS exhibited weak peaks with feeble intensities besides absence of some peaks. Though not decisive but it could be attributed to the presence of exploded explosive as an empirical evidence.

The RDX is a synthetic material and has the molecular formula $\text{C}_3\text{H}_6\text{N}_6\text{O}_6$; the structure is shown in the in-set of Figure 4. The oxygen atoms of nitro functional group ($-\text{NO}_2$) could be considered as comparable due to resonance i.e., $^+\text{O}=\text{N}=\text{O}$ and $\text{O}=\text{N}-\text{O}^+$. The $-\text{NO}_2$ group shows three degree of freedoms with respect to the bond vibrations: i) strong reflections in the region 1,530 to 1,560 cm^{-1} ; ii) moderate reflections in 1,210 to 1,360 cm^{-1} range; and iii) weak reflections in the region 840 to 930 cm^{-1} representing asymmetric, symmetric and bending frequencies, respectively [4, 9]. In experimental spectra of the present work, these reflections appeared at 1,541, 1,260 and 854 cm^{-1} .

Figure 4. Superimposed FTIR spectra of DSOS, SOS and OZ1a specimens indicating $-\text{NO}_2$ peaks. The referred FTIR spectrum of RDX is mentioned at the bottom, showing its compliance with the experimental results. Inset is showing molecular structure of RDX.

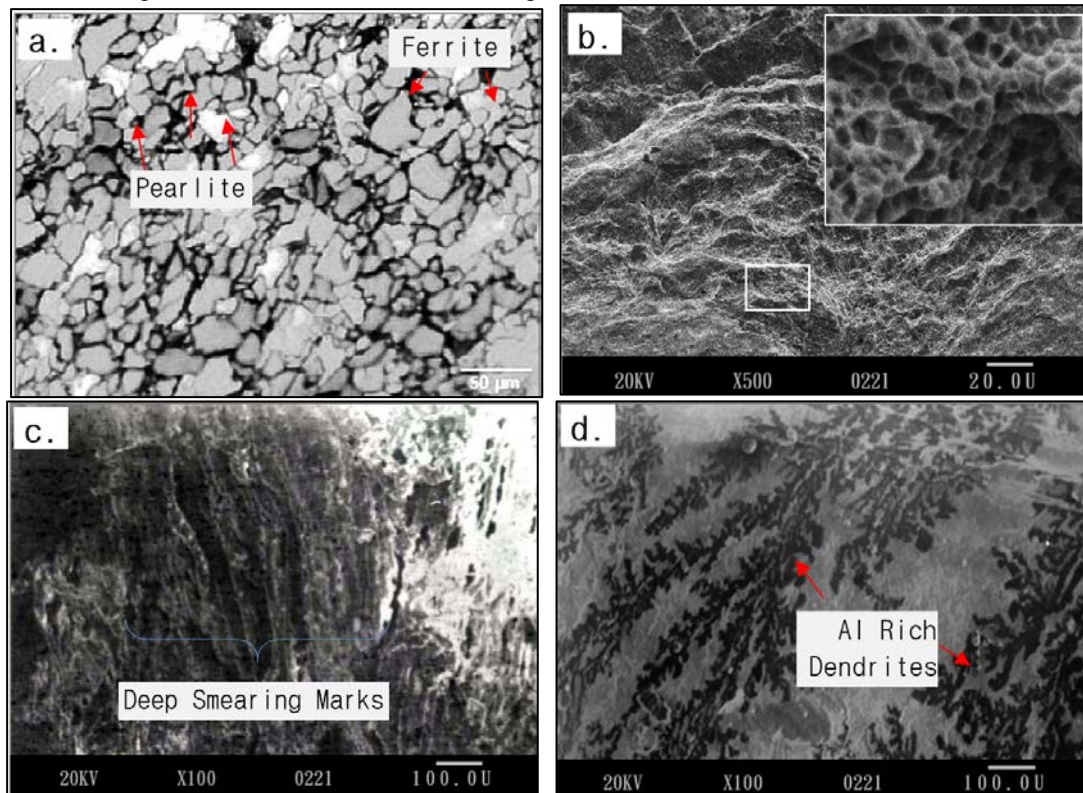
In specimen OZ-1, the general fracture morphology appeared to be dimple rupture, which was a clear indicative of ductile fracture. The size and shape of the dimples were very small fracture, which specified a fast-moving crack of catastrophic nature i.e., overload [13]. The features are shown in Figure-5b, where the inset is a high magnification (5000x) image, showing nature of the dimples.

The fracture surface of the deformed segment (DP-1) appeared to be largely smeared (Figure-5c). The smearing marks were uni-directional; indicating the direction of fracture features happened during the failure. At some locations, clusters of particles were also seen. The qualitative analysis of these clusters appeared to be rich in Al, Si, Ca and Mg in the descending order. Similarly, point analysis of different regions of the fractured surface confirmed the presence of these elements with Al contents at the first or second place.

A quite bizarre feature of metallic aluminum deposits was seen on the DP-2 fragment. These deposits were present in the

form of splashes on the fracture surface of the segment. The morphology of the splashes was like dendrites (Figure 5d), which suggested that the splashes were thin films of the solidified molten metal [14]. Such deposits were found only one location (DP-2), despite of thorough search of the rest of the failure regions.

Figure 5. Micrographs of various specimens revealing. a). Optical micrograph of the general structure showing pearlite colonies embedded in ferritic matrix, b). Fracture surface at OZ-1 revealing fine dimples of overload nature, c). Metal smearing on the fracture surface sectioned from DP-1 region, and d). Micrograph showing aluminum dendrites on the outer surface of disintegrated fragment DP-2.

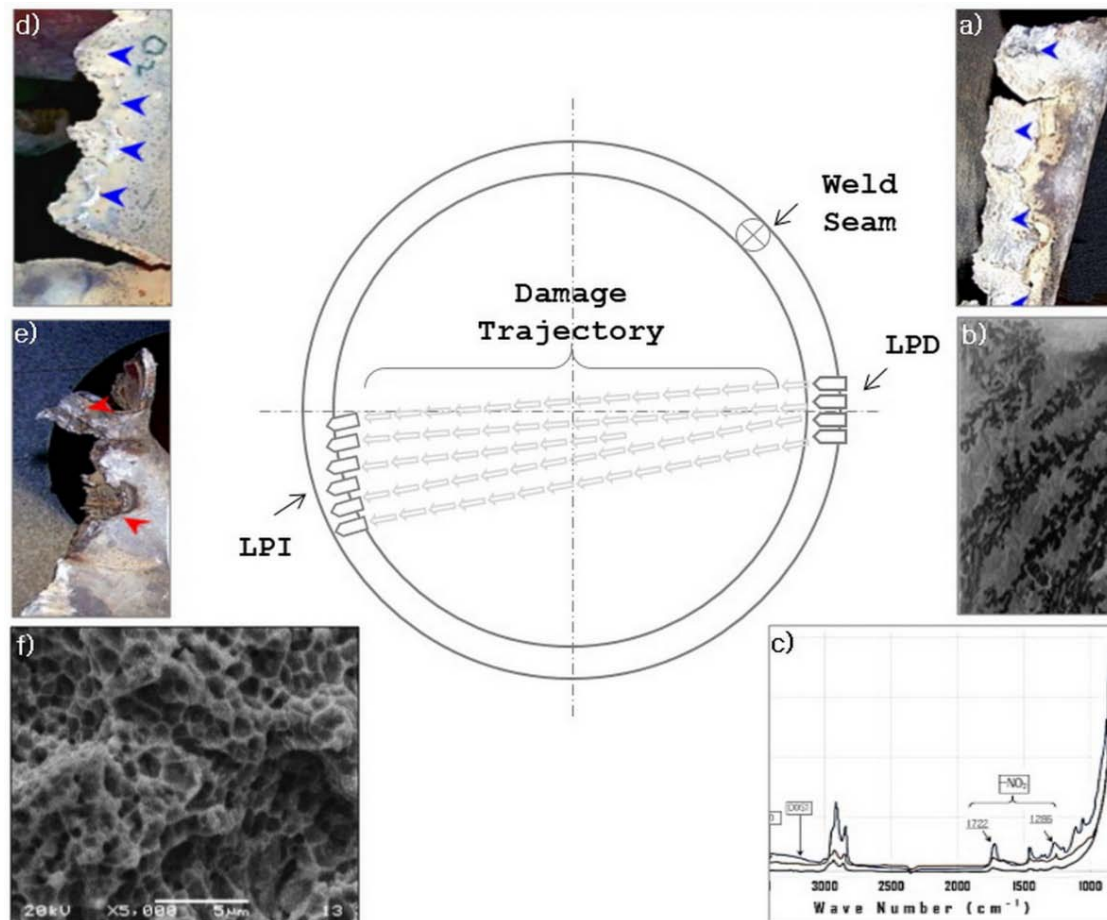
The observations were mapped on the periphery of the pipe for confirmation of any sequential damages (Figure 6). Two locations of the fracture surfaces of the entire failed region were distinctly identified by their features i.e., LPD and LPI as marked in Figure 6. These locations were almost opposite to each other.

At LPD location, some penetration/ingress type of fracture features was observed. These penetrations features were coarse in size, while having secondary cracks (Figure 6a). Additionally, at outer surface of the pipe external impact was the dominating feature accompanying smearing and localized deposits of molten aluminum metal. The molten metal appeared to be the splashed dendrites during SEM study (Figure 6b). These features were entirely unexpected under usual failure circumstances; hence, a wet analysis and FTIR were carried out on the deposits collected from the fracture surface and other corresponding regions i.e., from LPI region (SOS), from LPD region (DSOS) and segments of LPD region (OZ1a). The FTIR investigations indicated the presence of RDX traces on the fracture surface at this location (OZ1a), however outer and inner surfaces, which were bit away from it, did not show such evidences (Figure 6c). These features made the location LPD as primary fracture initiation point of the failure i.e., origin of the fracture.

At LPI location, a continuation of LPD devastation was observed, where the features of fracture surface depicted the penetration or fracture initiation from the inner side of the pipe (Figure 6d). It could be inferred that the debris and fragments from location LPD struck to the LPI location causing the fracture at this location from inner side. Moreover, the thinning of the pipe walls (Figure 6e) showed the overloading of the area at larger scale than LPD. The fractographic features of the location were overload type (Figure 6f).

Figure 6. Schematic representation of the evidences found on locations LPD and LPI:

a) Penetration from outer surface of the pipe, b) Presence of Al dendrites and c) FTIR spectra showing $-\text{NO}_2$ peaks, d) Penetration from inside of the pipe wall, e) Thinning of the pipe wall from inner side, and f) Overload fracture features.

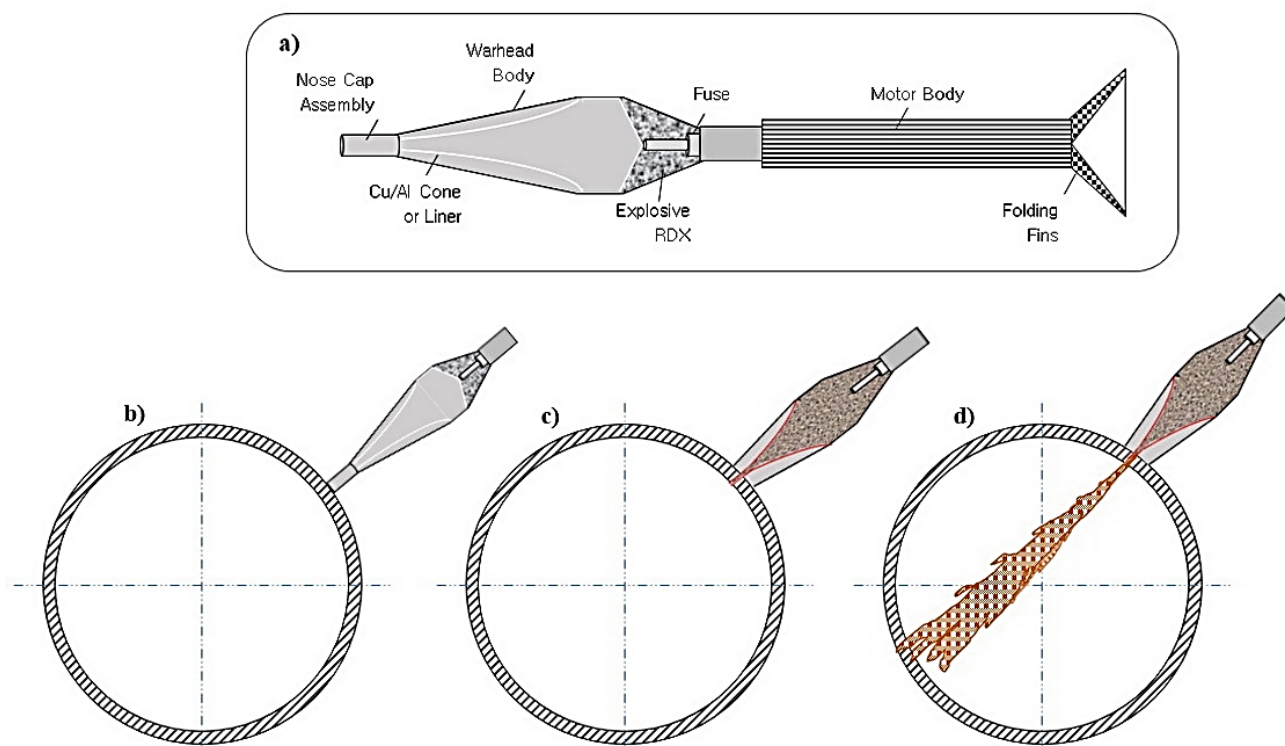
A probable sequence of failure, deduced from the preceding findings and discussion, is represented schematically in Figure-7. It would be prudent to understand the structure and working principle rocket propelled grenade (RPG-7) to follow the probable failure sequence. An RPG-7 rocket comprises two major parts: grenade and rocket. The grenade has nose cap assembly, followed by warhead assembly comprising a copper or aluminum liner and explosive charge. Rest of the assembly comprises rocket motor, which propagates the grenade to the target (Figure 7a). When the propelled RGP-7 approaches to the target (Figure 7b), the nose assembly ignites the explosive charge, which consequently pushes the metallic liner into the target and pierce through it (Figure 7c). The pierced hole provides a narrow passage for the pressurized gases inside the grenade to disintegrate the target catastrophically (Figure 7d) [19].

Based on the findings during investigation, the sequence of the failure could be as follows: at location LDP, penetration from the outer side was observed along with aluminum dendrites and presence of explosive material (Figure 6a to 6c), which could be the consequence of the first strike of an RPG rocket (Figure 7c). At location LPI, inside penetration, wall thinning and overload features (Figure 6d to 6f) were present, which represent the subsequent damage made by the rocket as demonstrated

in Figure 7d.

Figure 7. Schematic presentation of the sequence of the failure. a) layout of the RPG rocket, b) rocket approaching to the target, c) first damage and piercing and d) subsequent damage.
